Rockit Baby Rocker – Vibration Tests

A prototype Rockit was tested in September 2016.

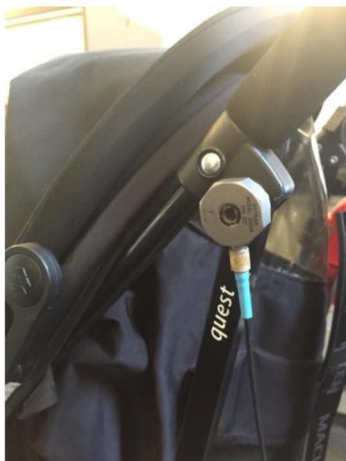
1. Top left rivet;
2. Bottom right rivet;
3. Bottom left rivet.

For reference the X and Y axes are the designated horizontal axes and the Z axis the vertical. The measurement locations are shown in the photographs below:

Top Left Rivet

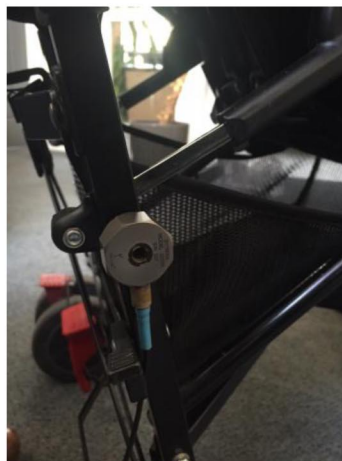
Bottom Right Rivet

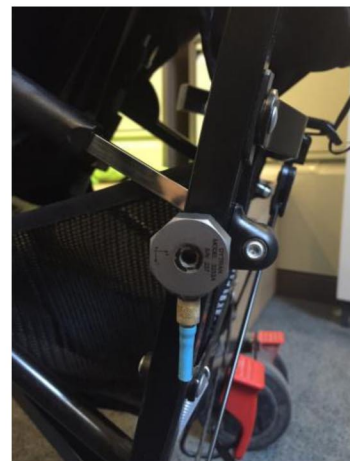
Bottom Left Rivet

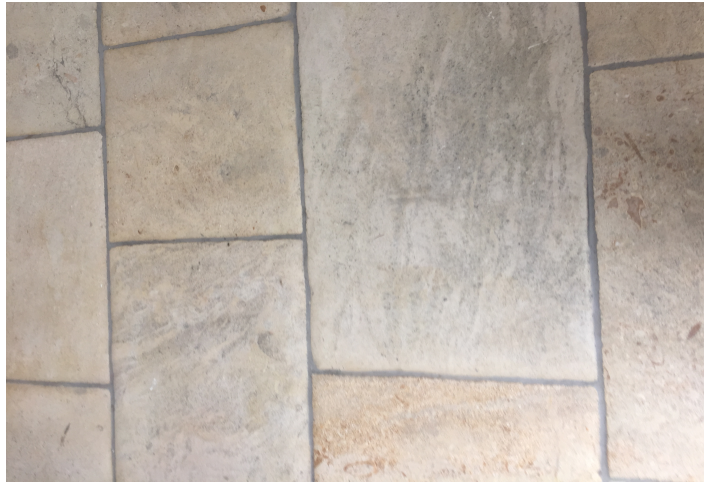
Below is a photo of the paving stones used for the fourth test condition:

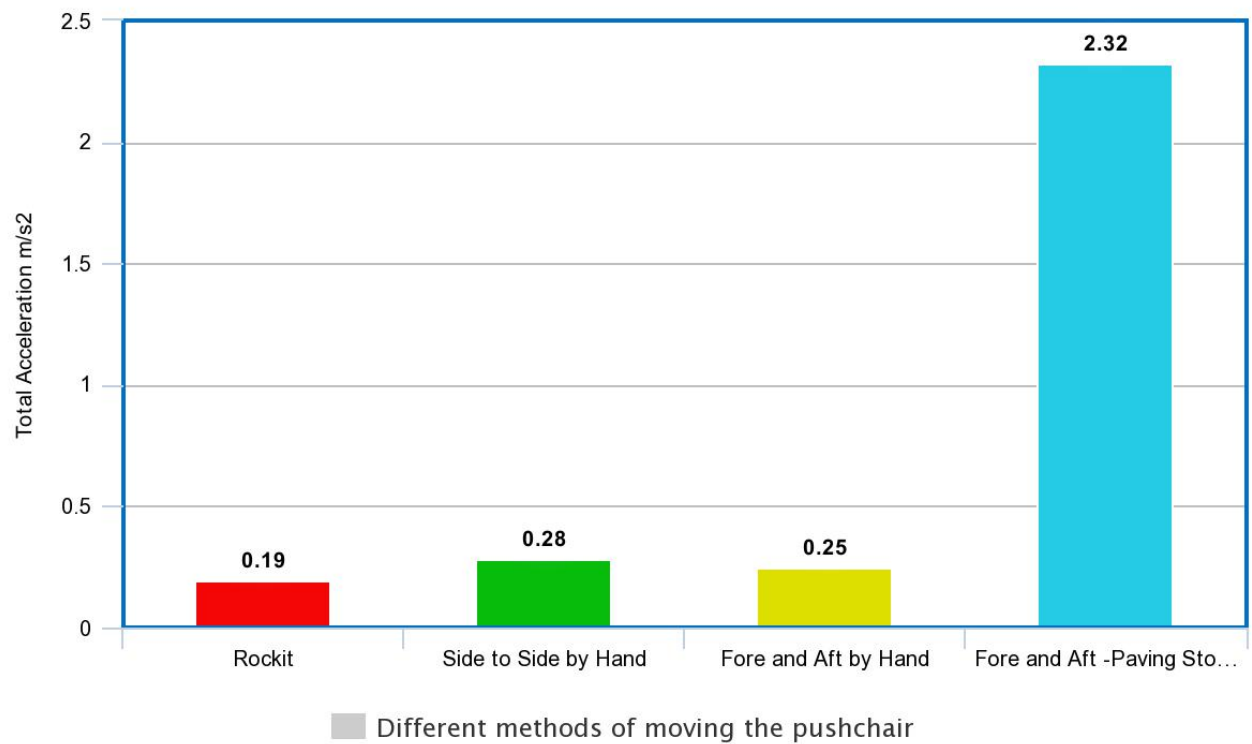
Figure 1: X-Axis Vibration Results, Top Left

The results shown below in figures 1-9 are the total acceleration levels measured with each accelerometer in each of the 3 axes. Total acceleration level is the RMS sum of each of the 1/3 octave bands. Figures 7-9 show the Y-axis vibration, which is the side-to-side motion of the Rockit.

The graphs show that the vibration levels from the Rockit and rocking the buggy by hand are approximately comparable in each of the measurements. Moving the pushchair over paving stones, a situation likely to be frequently encountered in everyday use of the buggy, resulted in significantly higher levels of acceleration.

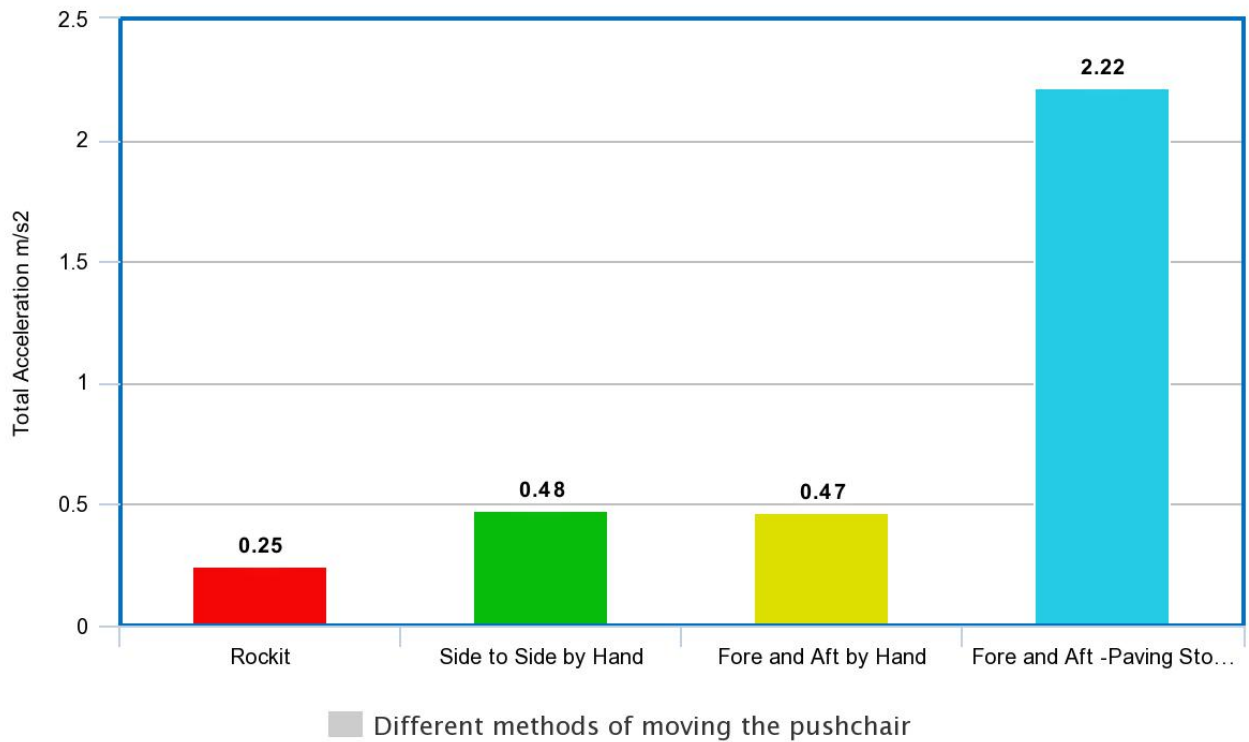
Figure 2: X-Axis Vibration Results, Bottom Right Rivet

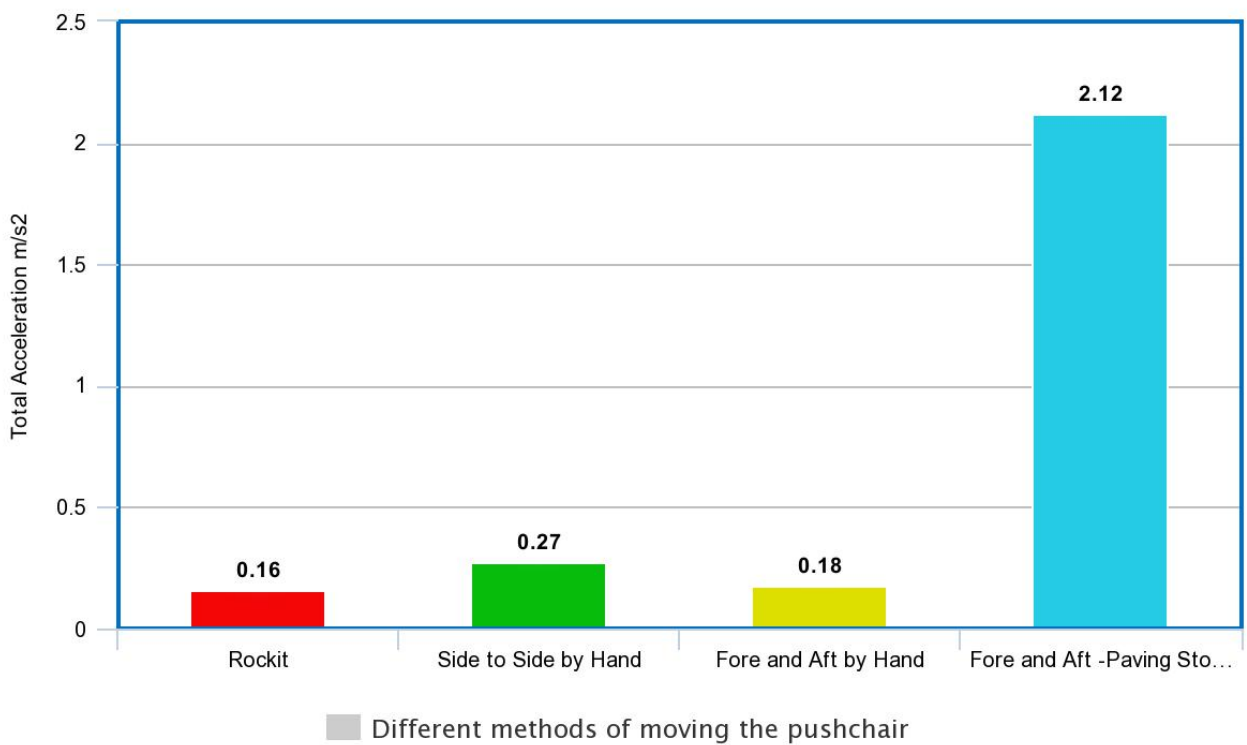
Figure 3: X-Axis Vibration Results, Bottom Left

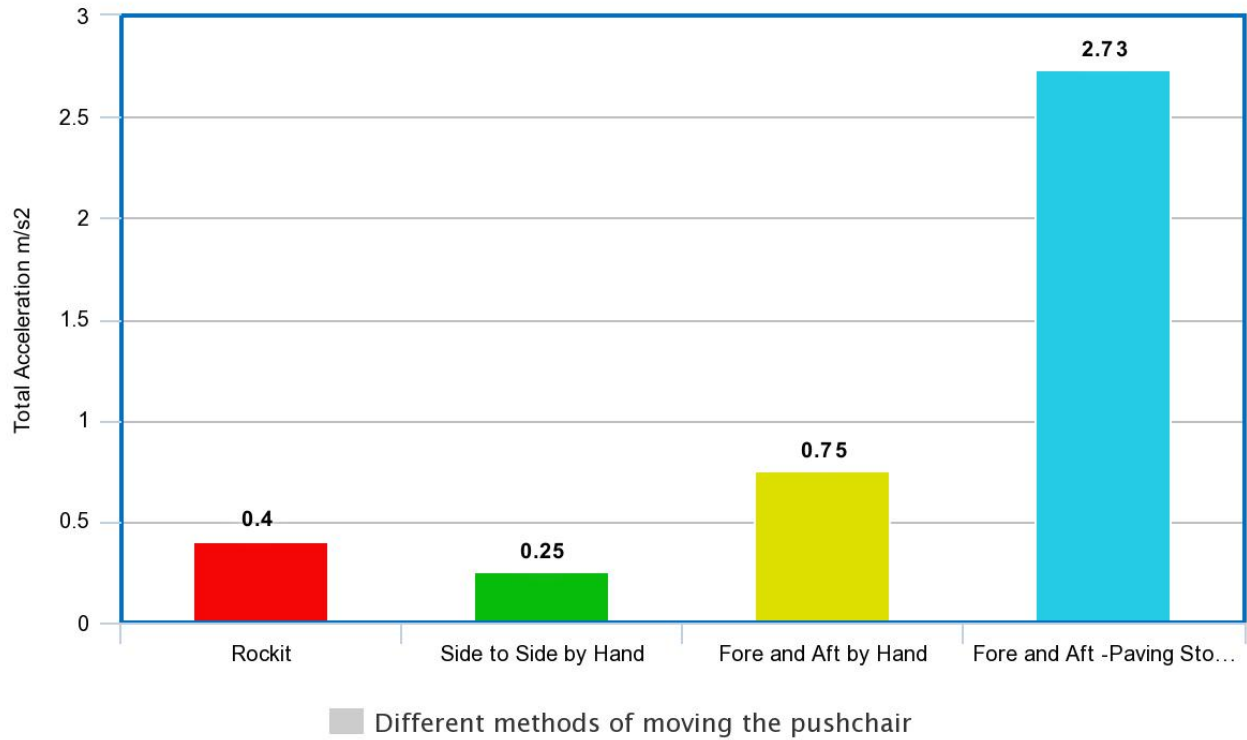
Figure 4: Z-Axis Vibration Results, Top Left

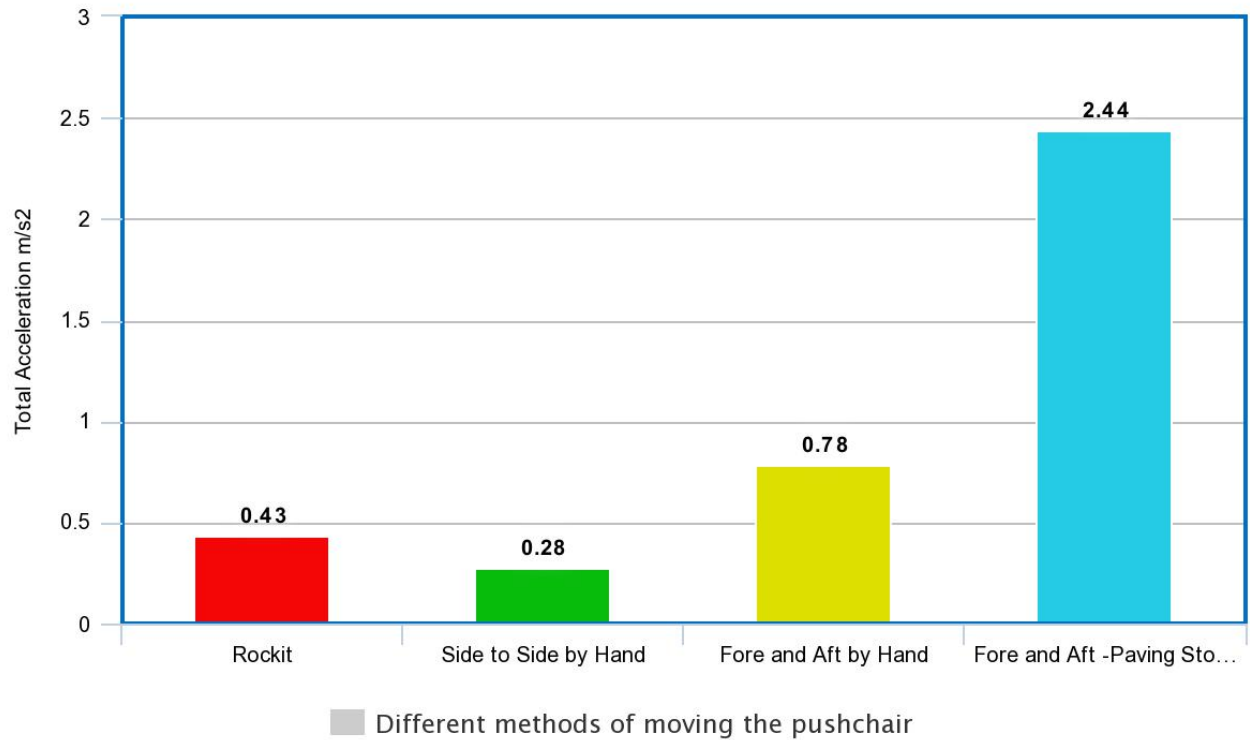
Figure 5: Z-Axis Vibration Results, Bottom Right

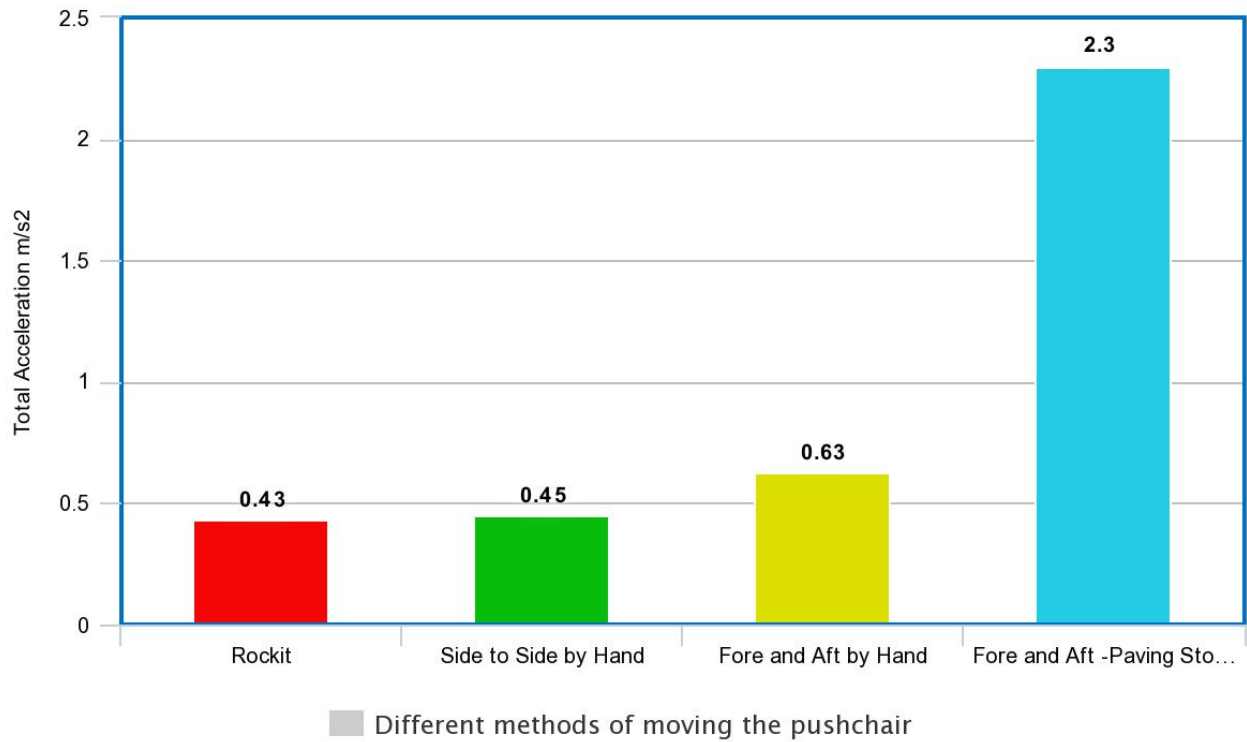
Figure 6: Z-Axis Vibration Results, Bottom Left

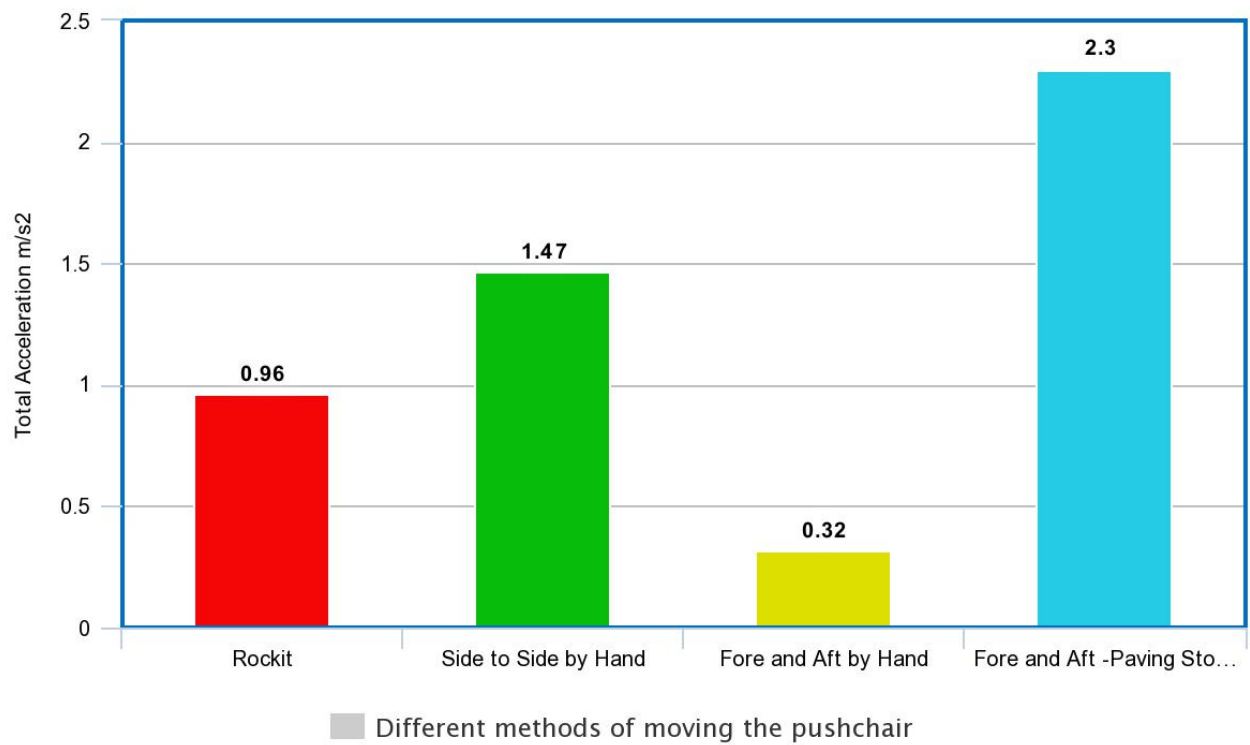
Figure 7: Y-Axis Vibration Results, Top Left

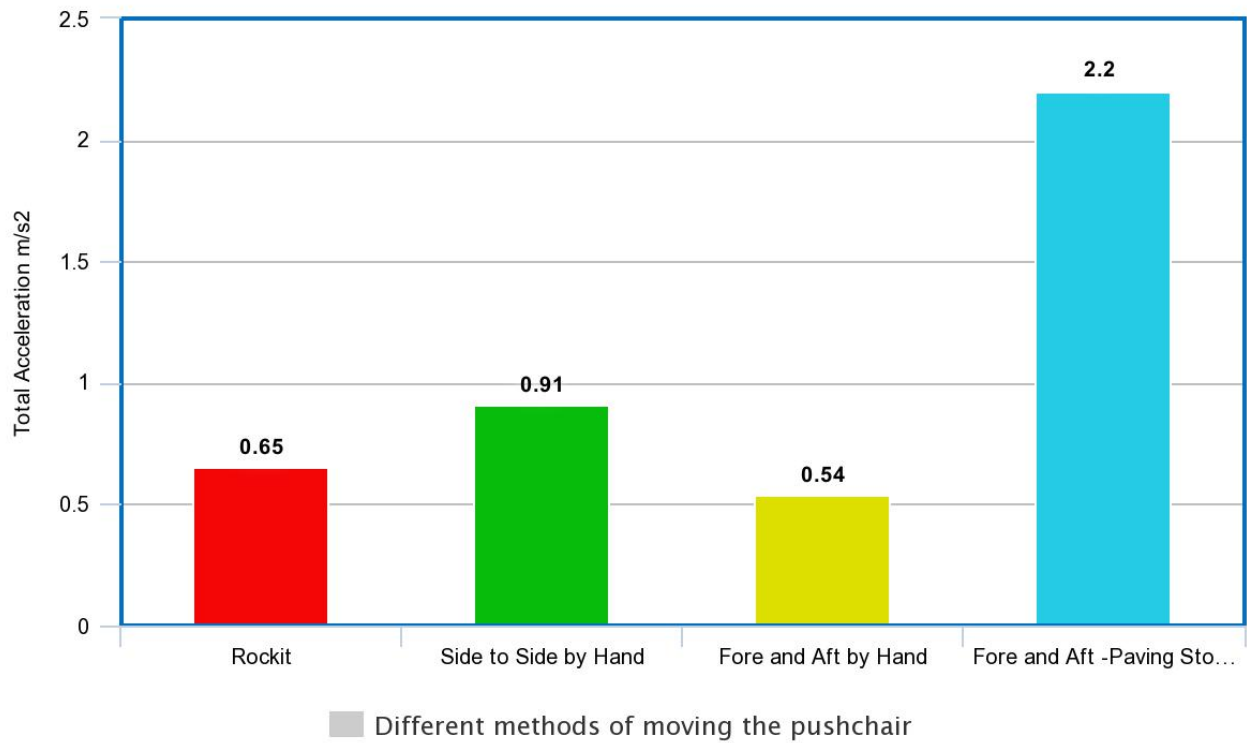
Figure 8: Y-Axis Vibration Results, Bottom Right

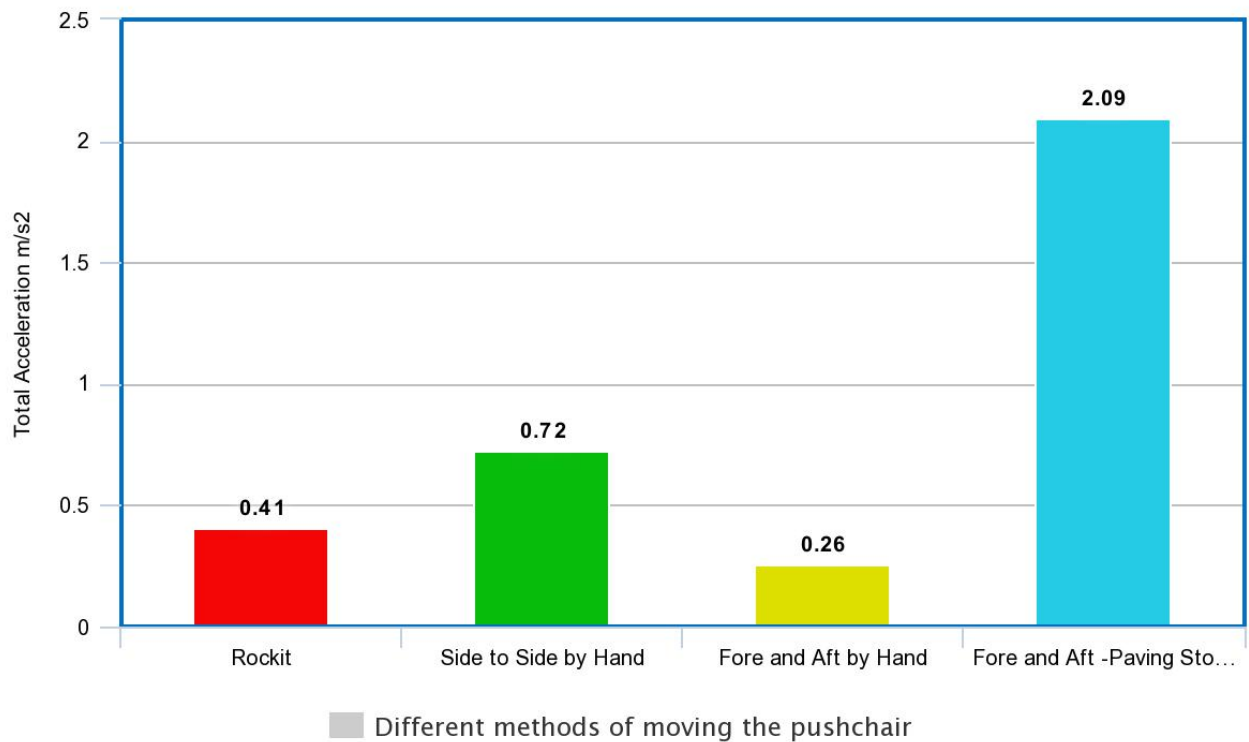
Figure 9: Y-Axis Vibration Results, Bottom Left
